# Deschutes Lower Indian Ford Riparian Restoration Post Implementation Status Report – Year 1 8/18/20 Prepared for: OWEB

Indian Ford Strategic Implementation Area Prepared by:

Erin Kilcullen – General Manager
Deschutes Soil and Water Conservation District

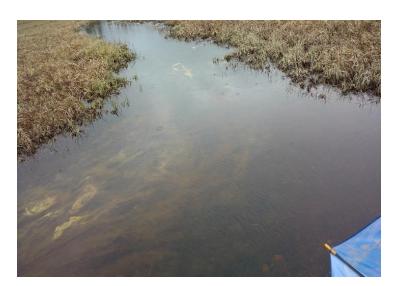
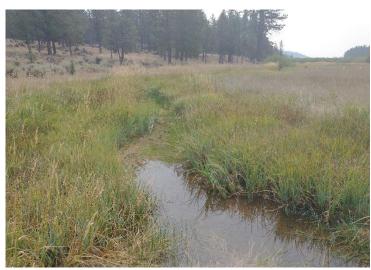
Downstream

# SIA Photo point 5 looking downstream at illegal ditch overflow from neighbor's pond back to Lower Indian Ford Creek where algae is present along with a reduced amount of water than diverted
