Deschutes Lower Indian Ford Riparian Restoration

Project Completion Report

Deschutes Soil and Water Conservation District

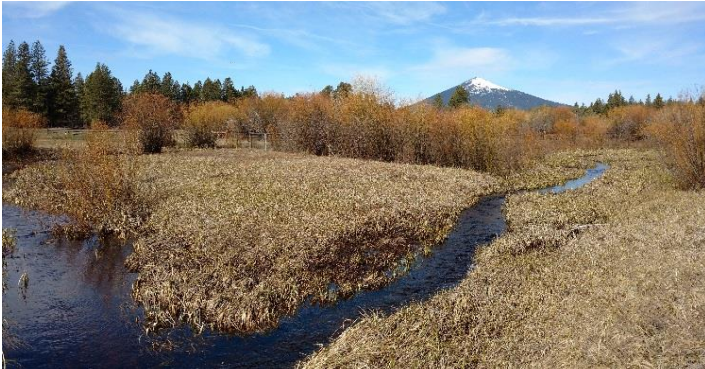
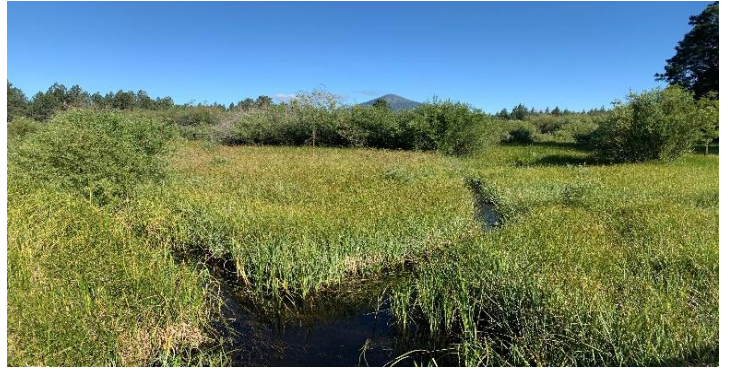
Willows Ranch point 1 looking upstream, & downstream photo point on small bridge

Upstream

From the photo points, you can see the positive results of fencing for cattle removal. This decreases the bank erosion drastically and allows the full potential for plant growth. It is great to see the outreach and education performed with the OYCP national guard crew and the Redmond School district and these efforts should be utilized in future restoration projects.

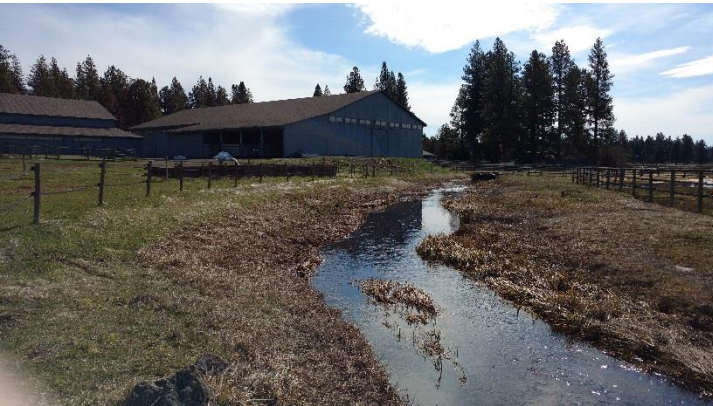
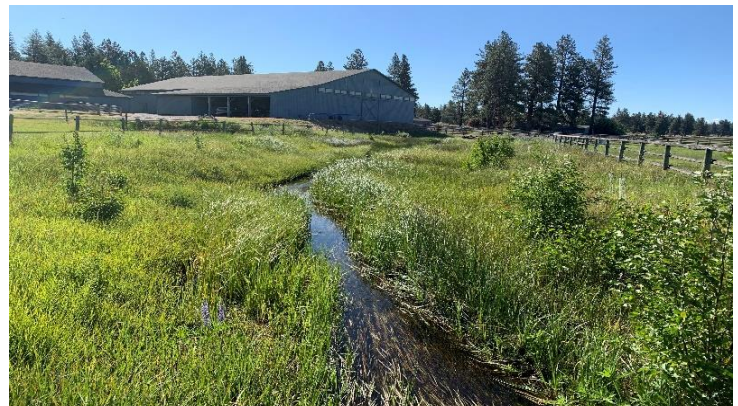
Downstream

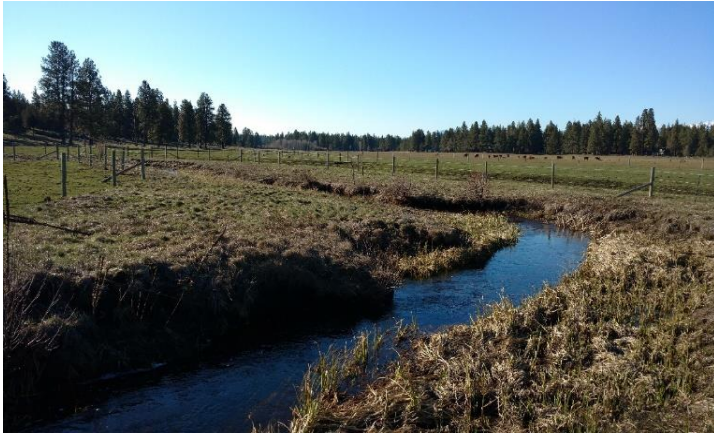
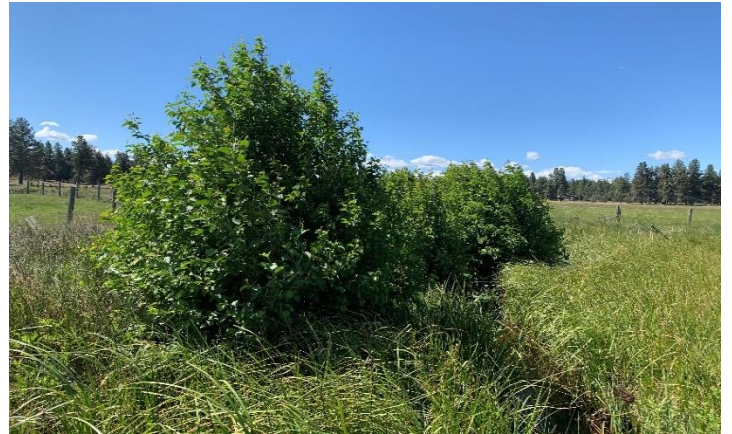
SIA Photo point 2

Downstream

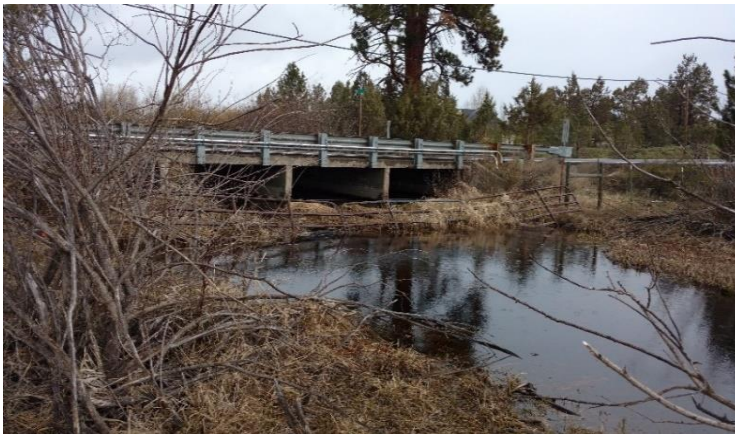
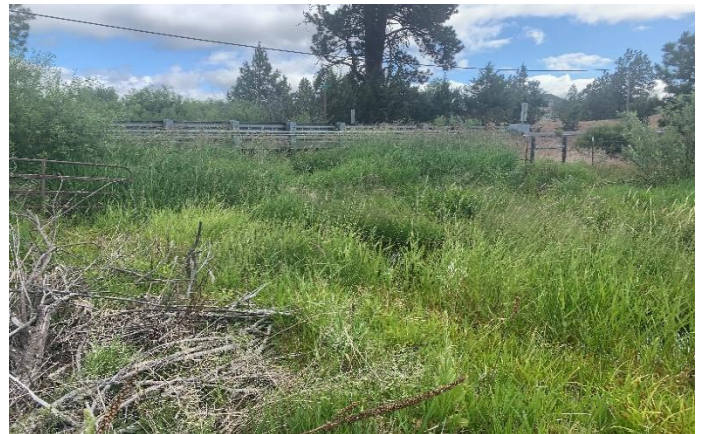
SIA Photo point 3 – Parrish Property – Bridge at Camp Polk Rd.

Upstream

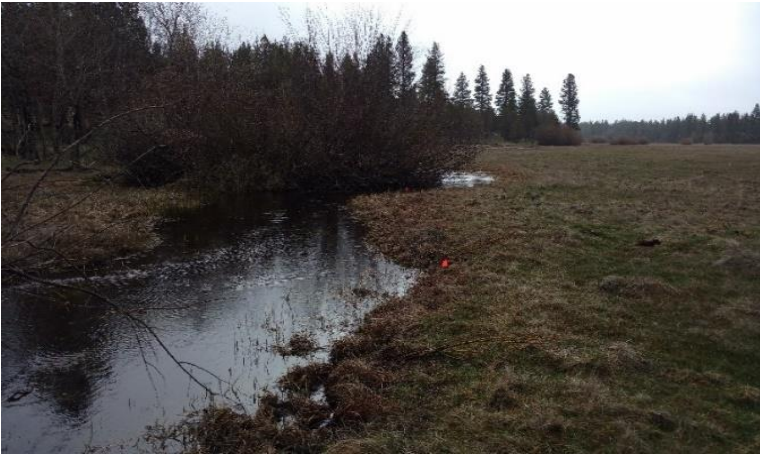
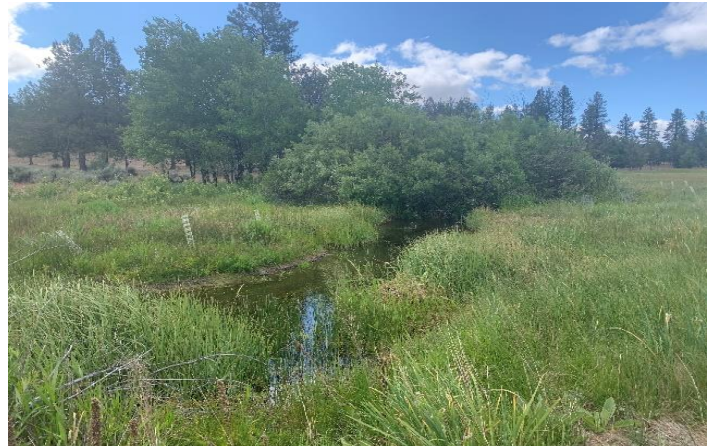
Downstream

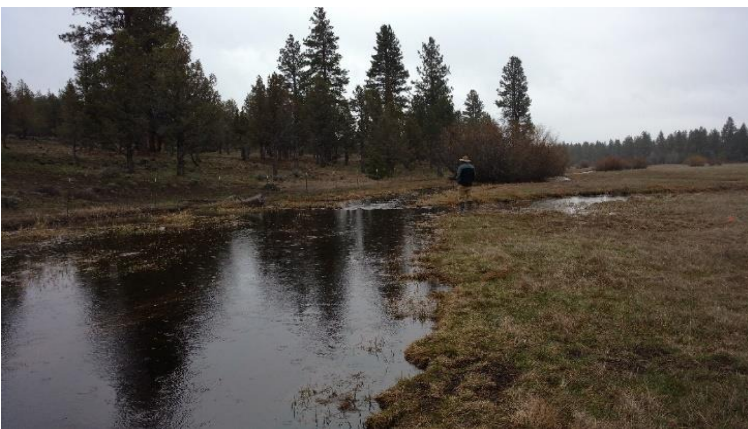
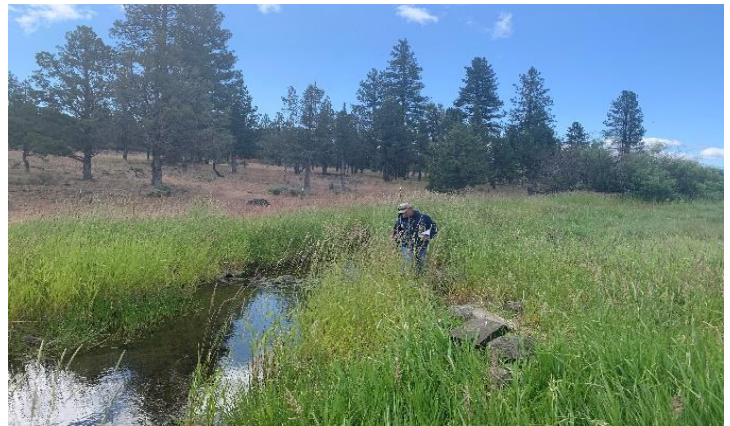
SIA Photo point 4 looking downstream at illegal ditch take off from pushup dam

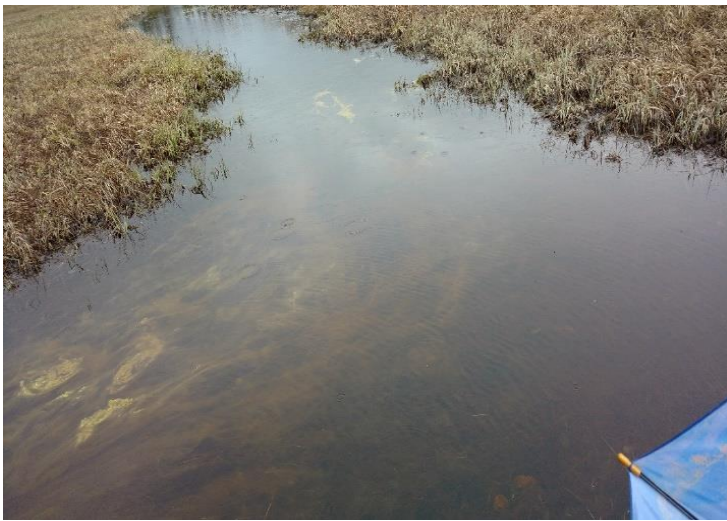
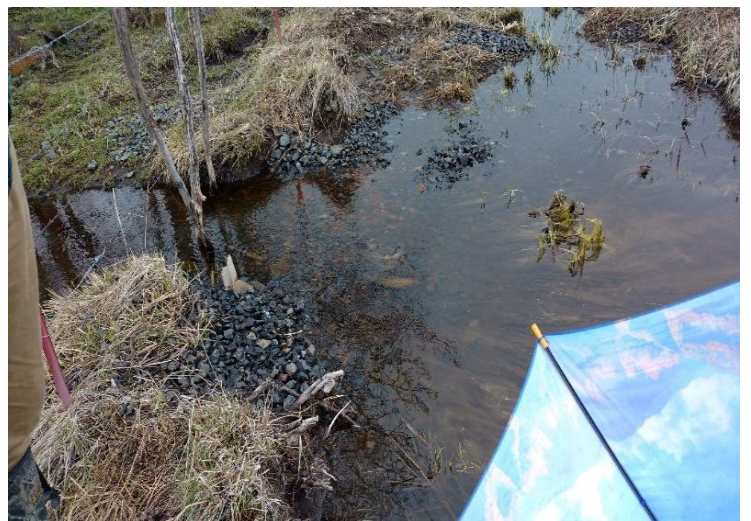
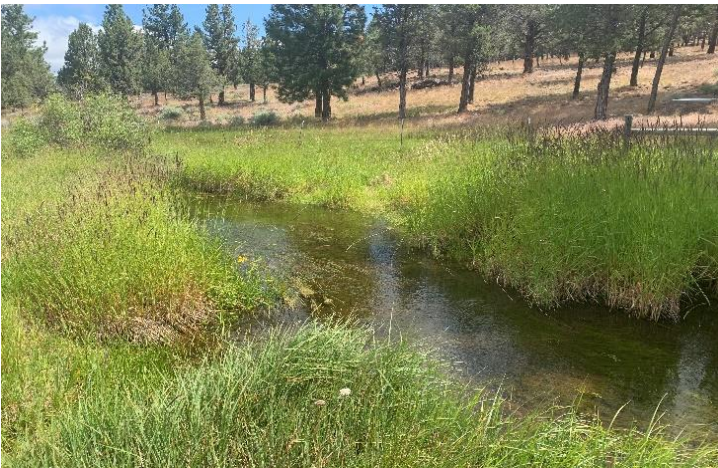
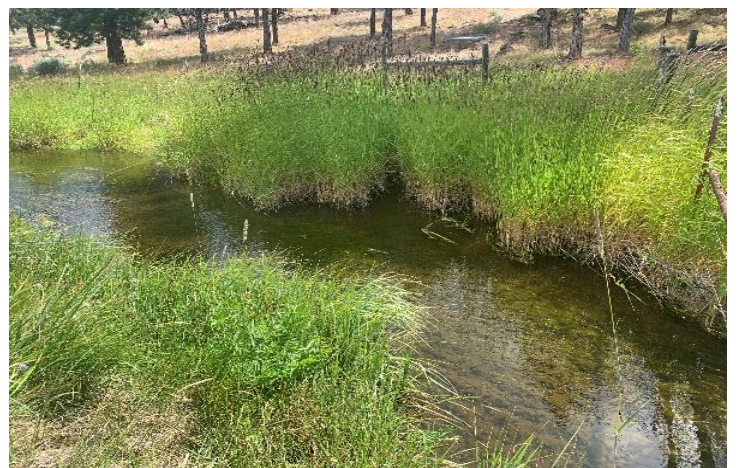
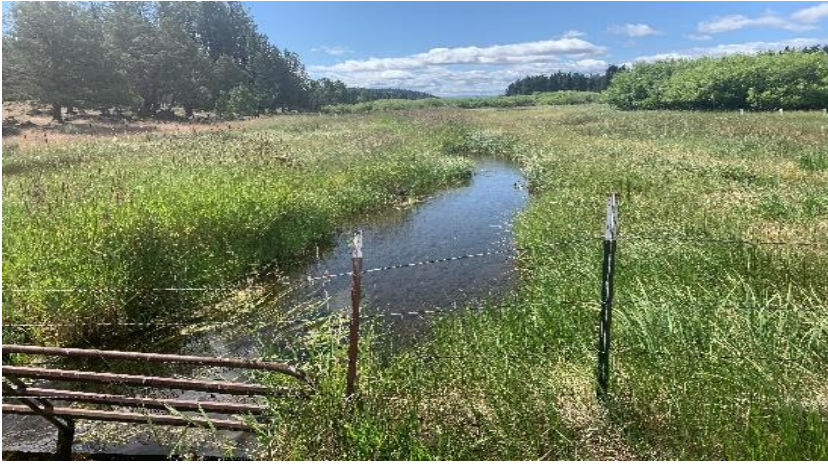
SIA Photo point 5 looking downstream at illegal ditch overflow from neighbor's pond back to Lower Indian Ford Creek where algae is present along with a reduced amount of water than diverted
